YOUR ONESURVEY
HOME REPORT

Corsemaul House
Dufftown, Keith
AB55 4EE

SINGLE SURVEY

Single Survey

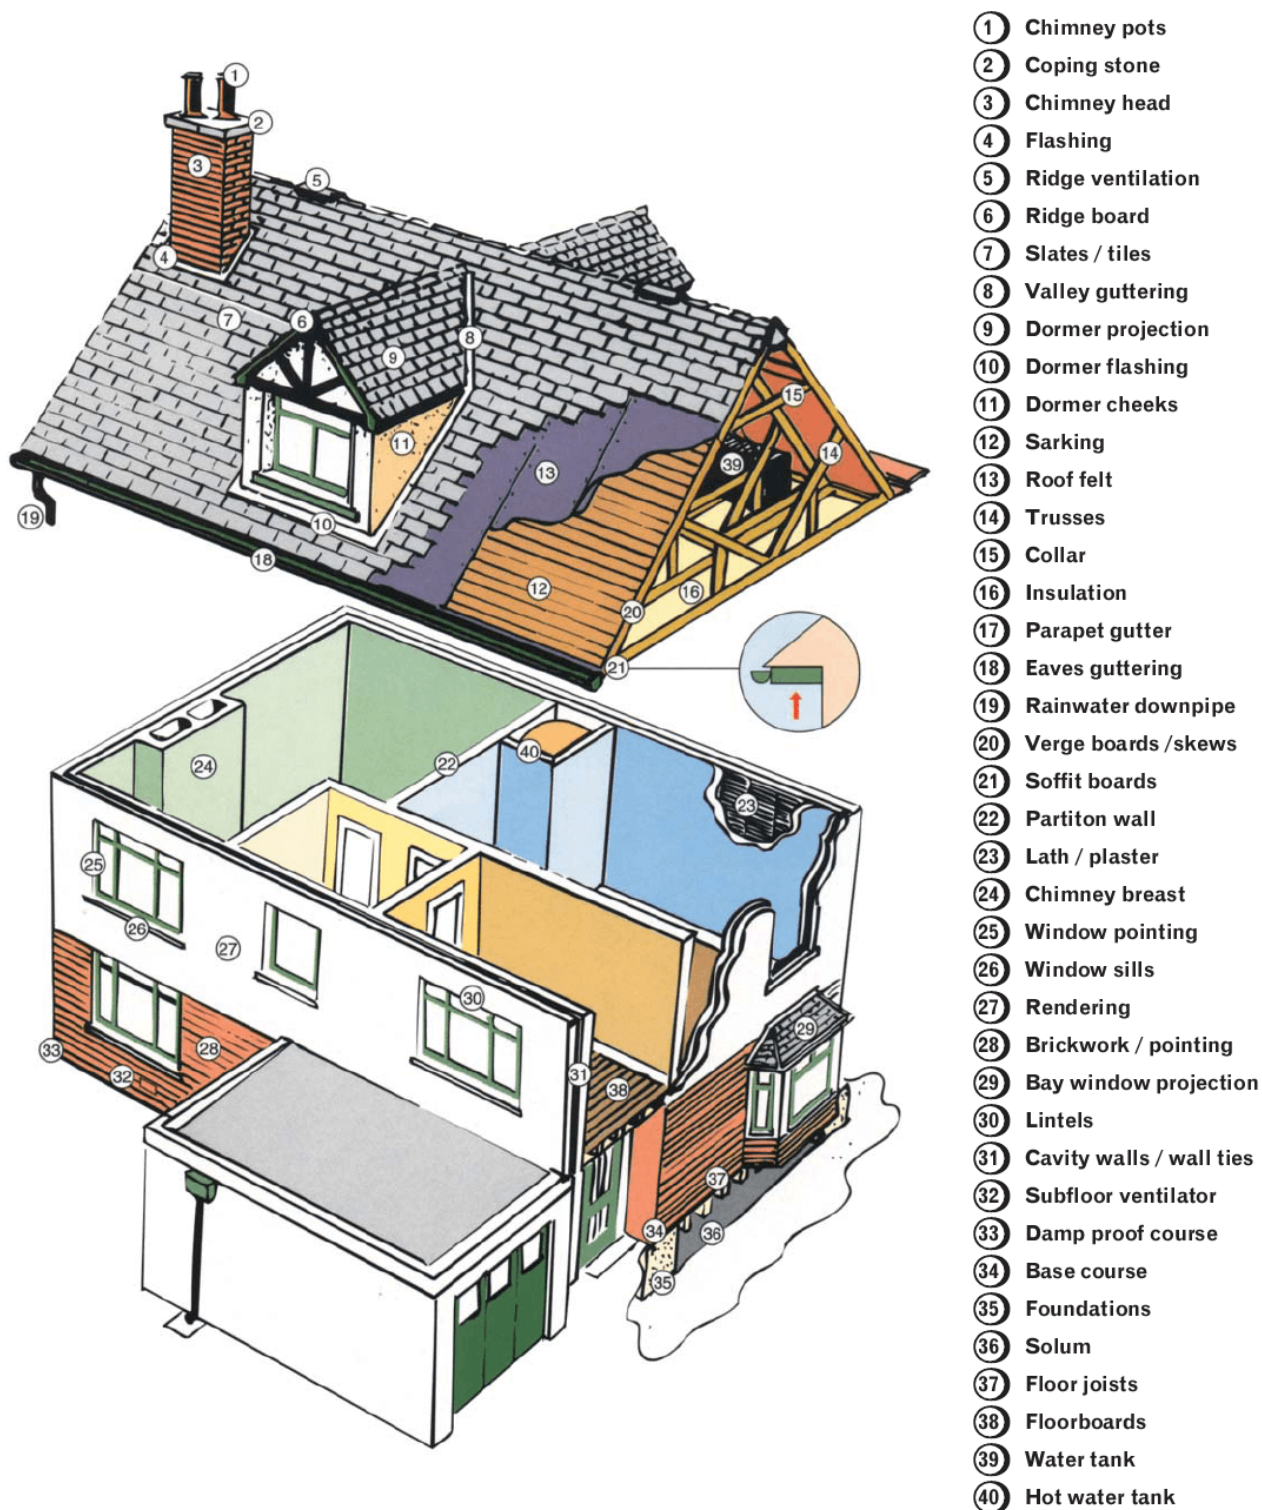
Sectional Diagram showing elements of a typical house

- ① Chimney pots
- ② Coping stone
- ③ Chimney head
- ④ Flashing
- ⑤ Ridge ventilation
- ⑥ Ridge board
- ⑦ Slates / tiles
- ⑧ Valley guttering
- ⑨ Dormer projection
- ⑩ Dormer flashing
- ⑪ Dormer cheeks
- ⑫ Sarking
- ⑬ Roof felt
- ⑭ Trusses
- ⑮ Collar
- ⑯ Insulation
- ⑰ Parapet gutter
- ⑱ Eaves guttering
- ⑲ Rainwater downpipe
- ⑳ Verge boards /skews
- ㉑ Soffit boards
- ㉒ Partiton wall
- ㉓ Lath / plaster
- ㉔ Chimney breast
- ㉕ Window pointing
- ㉖ Window sills
- ㉗ Rendering
- ㉘ Brickwork / pointing
- ㉙ Bay window projection
- ㉚ Lintels
- ㉛ Cavity walls / wall ties
- ㉜ Subfloor ventilator
- ㉝ Damp proof course
- ㉞ Base course
- ㉟ Foundations
- ㊱ Solum
- ㊲ Floor joists
- ㊳ Floorboards
- ㊴ Water tank
- ㊵ Hot water tank

Reference may be made in this report to some or all of the above component parts of the property. This diagram may assist you in locating and understanding these items.
