YOUR ONESURVEY HOME REPORT

17 Cathedral Court Elgin IV30 4BZ PREPARED FOR

SINGLE Survey

Single Survey

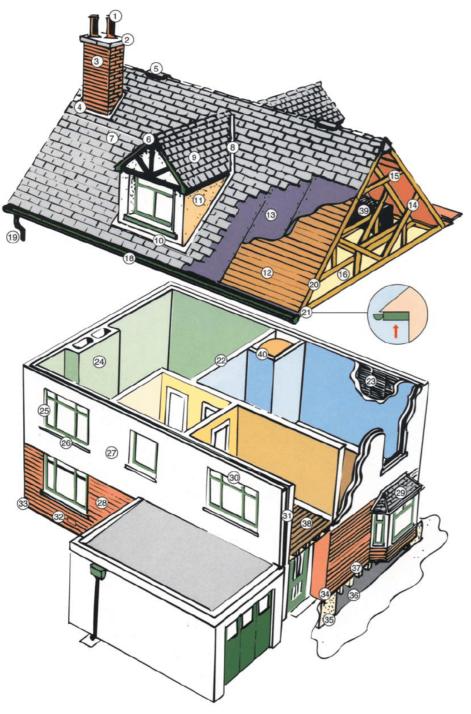
Sectional Diagram showing elements of a typical house

Reference may be made in this report to some or all of the above component parts of the property. This diagram may assist you in locating and understanding these items.

1	Chimney pots
2	Coping stone
3	Chimney head
(4)	Flashing
5	Ridge ventilation
6	Ridge board
1	Slates / tiles
8	Valley guttering
9	Dormer projection
10	Dormer flashing
11	Dormer cheeks
12	Sarking
13	Roof felt
14	Trusses
15	Collar
16	Insulation
17	Parapet gutter
18	Eaves guttering
19	Rainwater downpipe
20	Verge boards /skews
21	Soffit boards
22	Partiton wall
23	Lath / plaster
24	Chimney breast
25	Window pointing
26	Window sills
27	Rendering
28	Brickwork / pointing
29	Bay window projection
30	Lintels
31	Cavity walls / wall ties
32	Subfloor ventilator
33	Damp proof course
34	Base course
35	Foundations
36	Solum
37	Floor joists
38	Floorboards
39	Water tank
40	Hot water tank
