YOUR ONESURVEY HOME REPORT

Midport Cottage Grantown-on-Spey PH26 3PJ

SINGLE Survey

Single Survey

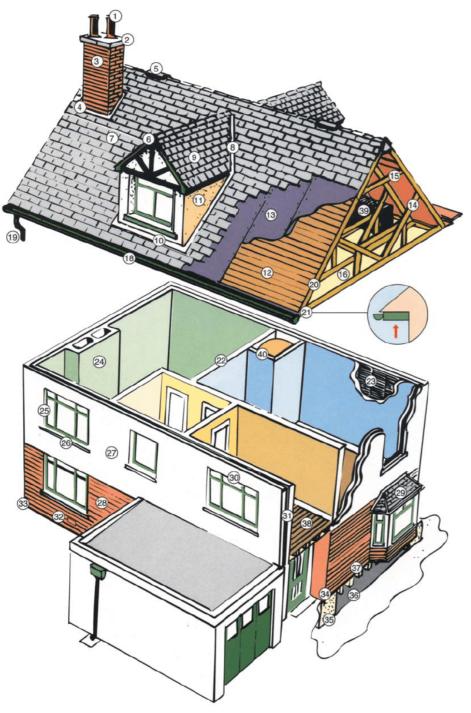
Sectional Diagram showing elements of a typical house

Chimney head (3) Flashing (4)**Ridge ventilation** (5) Ridge board (6) Slates / tiles ി Valley guttering (8) (9) Dormer projection (10) Dormer flashing (11) Dormer cheeks (12) Sarking (13) Roof felt (14) Trusses (15) Collar (16) Insulation (17) Parapet gutter (18) Eaves guttering (19) Rainwater downpipe Verge boards/skews 20 Soffit boards (21) Partiton wall (22) Lath / plaster (23) (24) Chimney breast Window pointing (25) Window sills (26) Rendering (27) (28) Brickwork / pointing (29) Bay window projection (30) Lintels (31) Cavity walls / wall ties (32) Subfloor ventilator 33) Damp proof course Base course (34) Foundations (35) Solum (36) Floor joists (37) Floorboards 38) Water tank (39)

Chimney pots Coping stone
