YOUR ONESURVEY HOME REPORT

Springfield Glen Road Newtonmore PH20 1BH

Single Survey

Selling address	Springfield
	Glen Road
	Newtonmore
	PH20 1BH

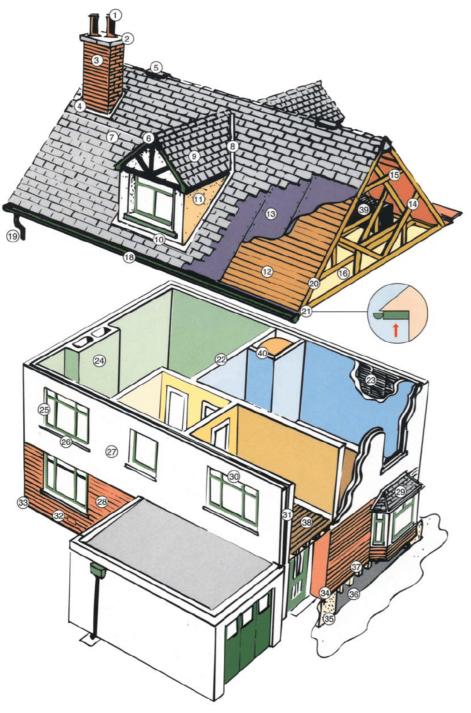
Sectional Diagram showing elements of a typical house

Chimney head (3) Flashing (4)**Ridge ventilation** (5) Ridge board (6) Slates / tiles ി (8) Valley guttering (9) Dormer projection (10) Dormer flashing (11) Dormer cheeks (12) Sarking (13) Roof felt (14) Trusses (15) Collar (16) Insulation (17) Parapet gutter (18) Eaves guttering (19) Rainwater downpipe Verge boards/skews 20 Soffit boards (21) Partiton wall (22) Lath / plaster (23) (24) Chimney breast Window pointing (25) Window sills (26) (27) Rendering (28) Brickwork / pointing (29) Bay window projection 30 Lintels (31) Cavity walls / wall ties (32) Subfloor ventilator 33) Damp proof course Base course (34) Foundations (35) Solum (36) Floor joists (37) Floorboards 38) Water tank (39)

Chimney pots Coping stone

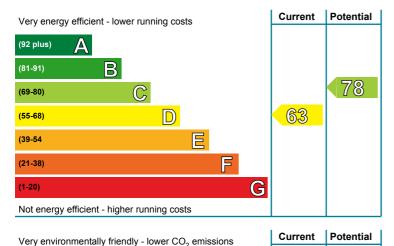
Energy Efficiency Rating

This graph shows the current efficiency of your home, taking into account both energy efficiency and fuel costs. The higher this rating, the lower your fuel bills are likely to be.
