YOUR ONESURVEY  
**HOME REPORT**

92 Main Street  
Tomintoul, Ballindalloch  
AB37 9HA

# SINGLE SURVEY

A report on the condition of the property, with categories being rated from 1 to 3.

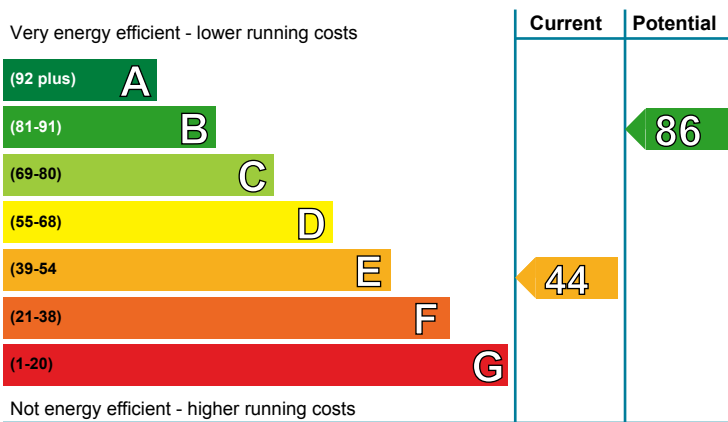
## Energy Efficiency Rating

This graph shows the current efficiency of your home, taking into account both energy efficiency and fuel costs. The higher this rating, the lower your fuel bills are likely to be.

Your current rating is **band E (44)**. The average rating for EPCs in Scotland is **band D (61)**.

The potential rating shows the effect of undertaking all of the improvement measures listed within your recommendations report.
