YOUR ONESURVEY HOME REPORT

79a High Street Aberlour AB38 9QB

SINGLE SURVEY

A report on the condition of the property, with categories being rated from 1 to 3.

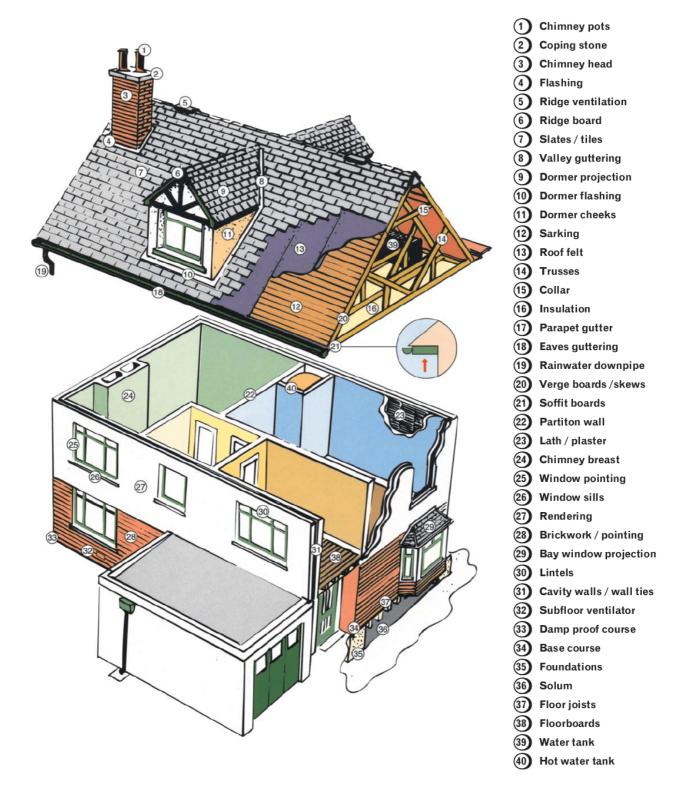
Sectional Diagram showing elements of a typical house

Reference may be made in this report to some or all of the above component parts of the property. This diagram may assist you in locating and understanding these items.
