YOUR ONESURVEY HOME REPORT

Achbreck
Glenrinnas, Keith
AB55 4BZ

SINGLE SURVEY

Single Survey

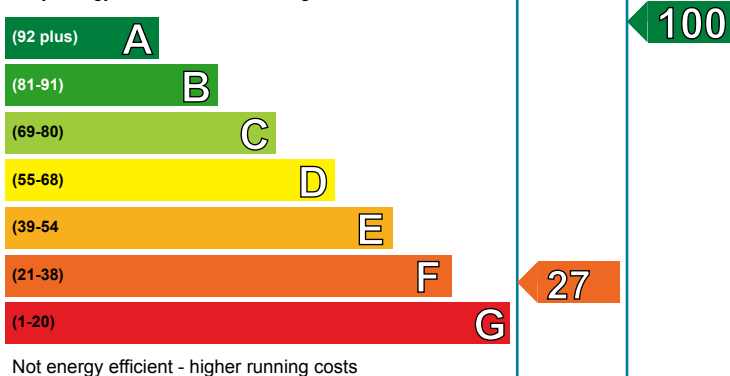
Energy Efficiency Rating

This graph shows the current efficiency of your home, taking into account both energy efficiency and fuel costs. The higher this rating, the lower your fuel bills are likely to be.

The potential rating shows the effect of undertaking all of the improvement measures listed within your recommendations report.

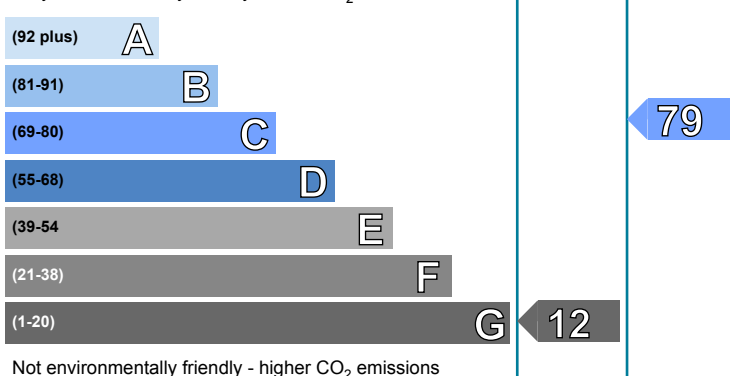
Environmental Impact (CO₂) Rating

This graph shows the effect of your home on the environment in terms of carbon dioxide (CO₂) emissions. The higher the rating, the less impact it has on the environment.
