YOUR ONESURVEY HOME REPORT

41 Birch Grove Boat of Garten PH24 3BA

SINGLE SURVEY

Surveyor Reference	IS230524
Executry Of	Mr. Robert Davidson
Selling address	41 Birch Grove Boat of Garten PH24 3BA
Date of Inspection	21/03/2023
Prepared by	Calum Riach, MRICS D M Hall - Inverness

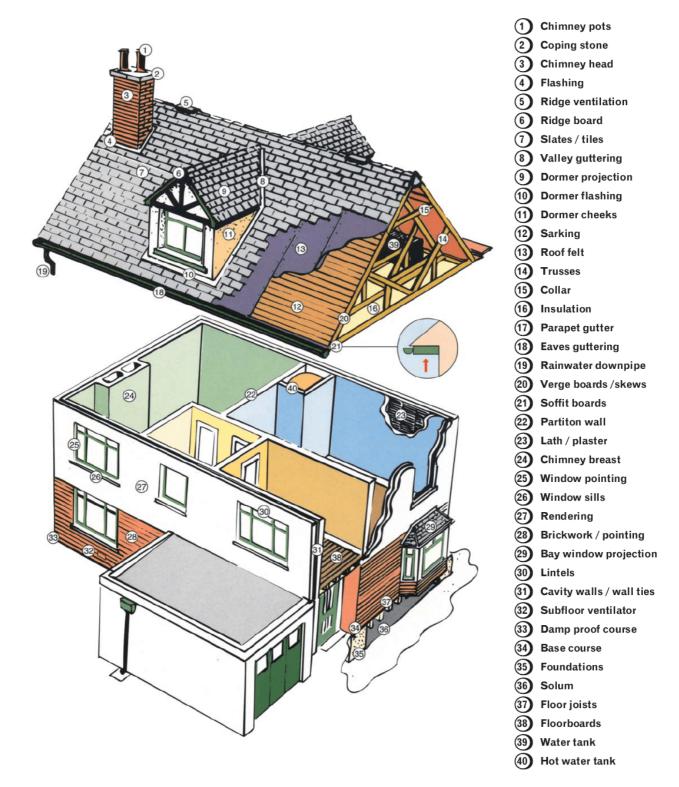
Sectional Diagram showing elements of a typical house

Reference may be made in this report to some or all of the above component parts of the property. This diagram may assist you in locating and understanding these items.
