YOUR ONESURVEY HOME REPORT

2 Post Office Cottages
Dulnain Bridge
PH26 3LT

SINGLE SURVEY

Surveyor Reference	IS240267
Customer	Mr. Kenneth Taylor
Selling address	2 Post Office Cottages Dulnain Bridge PH26 3LT
Date of Inspection	22/02/2024
Prepared by	Calum Riach, MRICS D M Hall - Inverness

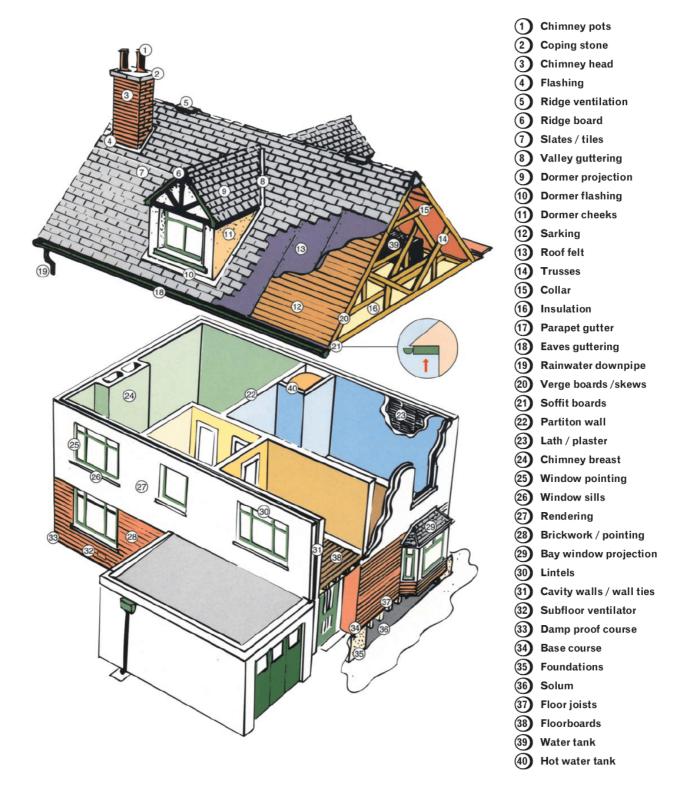
Sectional Diagram showing elements of a typical house

Reference may be made in this report to some or all of the above component parts of the property. This diagram may assist you in locating and understanding these items.
