YOUR ONESURVEY HOME REPORT

Carrickstane
Tomintoul, Ballindalloch
AB37 9HP

SINGLE SURVEY

Single Survey

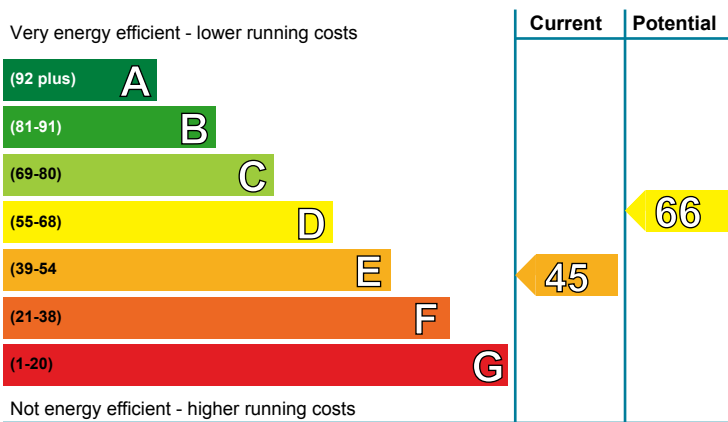
Energy Efficiency Rating

This graph shows the current efficiency of your home, taking into account both energy efficiency and fuel costs. The higher this rating, the lower your fuel bills are likely to be.

Your current rating is **band E (45)**. The average rating for EPCs in Scotland is **band D (61)**.

The potential rating shows the effect of undertaking all of the improvement measures listed within your recommendations report.

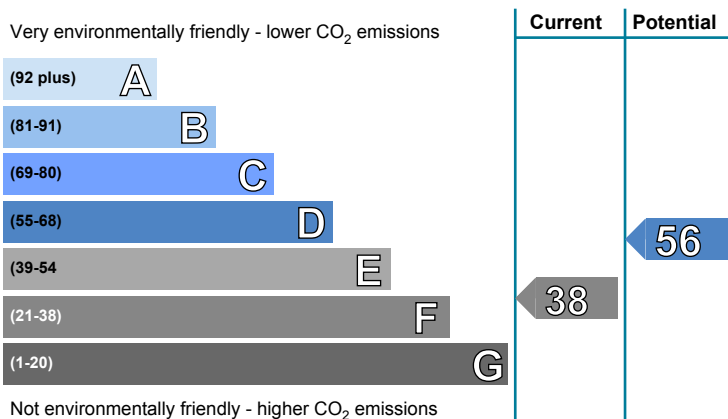
Environmental Impact (CO₂) Rating

This graph shows the effect of your home on the environment in terms of carbon dioxide (CO₂) emissions. The higher the rating, the less impact it has on the environment.
