YOUR ONESURVEY HOME REPORT

Lanson Broomhill Nethy Bridge PH26 3LX

SINGLE SURVEY

Surveyor Reference	IS250416
Customer	Mr. Ken Rowley
Selling address	Lanson
	Broomhill
	Nethy Bridge
	PH26 3LX
Date of Inspection	26/02/2025
Prepared by	Calum Riach, MRICS D M Hall - Inverness

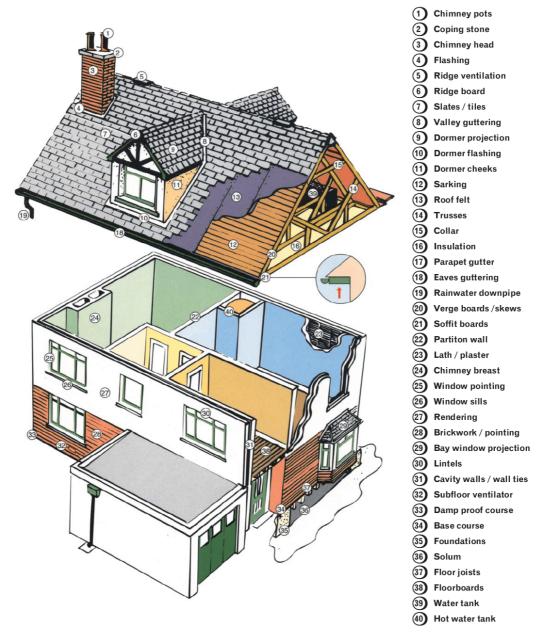
Sectional Diagram showing elements of a typical house

Reference may be made in this report to some or all of the above component parts of the property. This diagram may assist you in locating and understanding these items.
