YOUR ONE SURVEY
HOME REPORT

Dunstaffnage House
Woodside Avenue
Grantown-on-Spey
PH26 3JR

SINGLE SURVEY

Single Survey

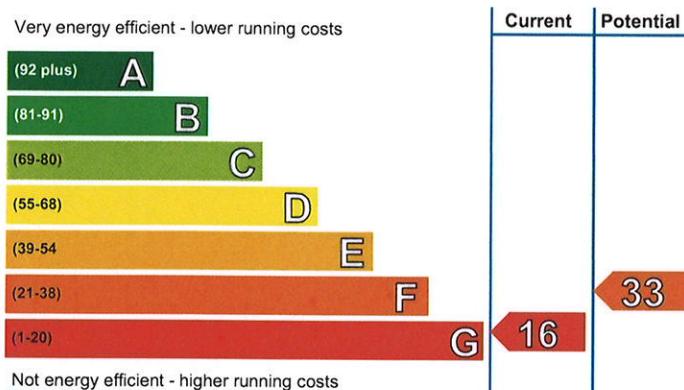
Energy Efficiency Rating

This graph shows the current efficiency of your home, taking into account both energy efficiency and fuel costs. The higher this rating, the lower your fuel bills are likely to be.

Your current rating is **band G (16)**. The average rating for EPCs in Scotland is **band D (61)**.

The potential rating shows the effect of undertaking all of the improvement measures listed within your recommendations report.

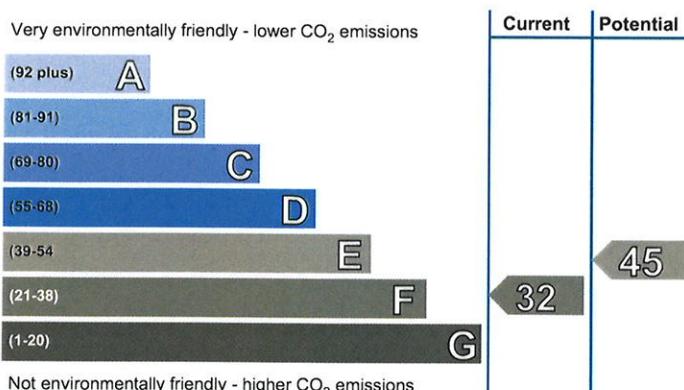
Environmental Impact (CO₂) Rating

This graph shows the effect of your home on the environment in terms of carbon dioxide (CO₂) emissions. The higher the rating, the less impact it has on the environment.

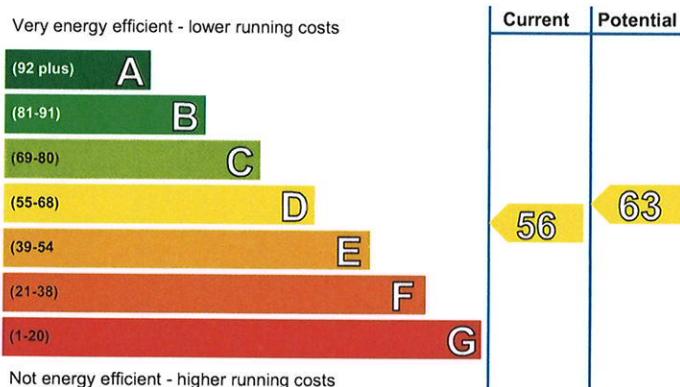
Energy Efficiency Rating

This graph shows the current efficiency of your home, taking into account both energy efficiency and fuel costs. The higher this rating, the lower your fuel bills are likely to be.

Your current rating is **band D (56)**. The average rating for EPCs in Scotland is **band D (61)**.

The potential rating shows the effect of undertaking all of the improvement measures listed within your recommendations report.

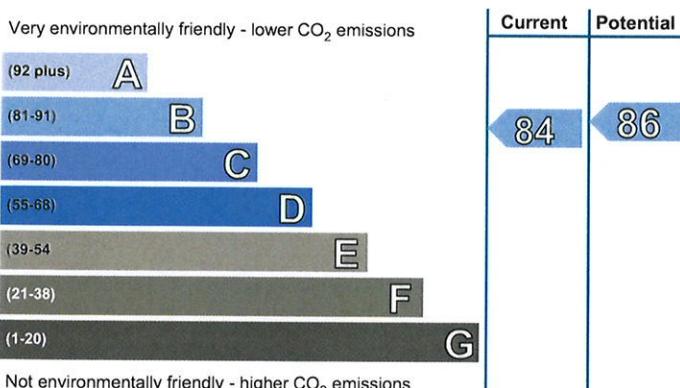
Environmental Impact (CO₂) Rating

This graph shows the effect of your home on the environment in terms of carbon dioxide (CO₂) emissions. The higher the rating, the less impact it has on the environment.
