# YOUR ONESURVEY HOME REPORT

Upper Finlarig  
Dulnain Bridge  
Grantown-on-Spey  
PH26 3NU

# SINGLE SURVEY

A report on the condition of the property, with categories being rated from 1 to 3.

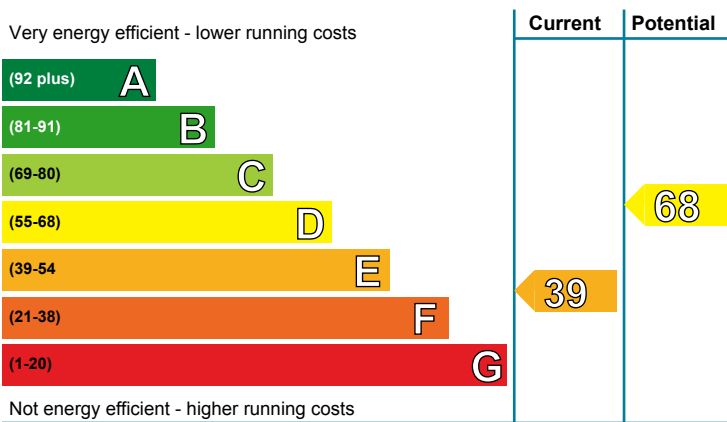
## Energy Efficiency Rating

This graph shows the current efficiency of your home, taking into account both energy efficiency and fuel costs. The higher this rating, the lower your fuel bills are likely to be.

Your current rating is **band E (39)**. The average rating for EPCs in Scotland is **band D (61)**.

The potential rating shows the effect of undertaking all of the improvement measures listed within your recommendations report.

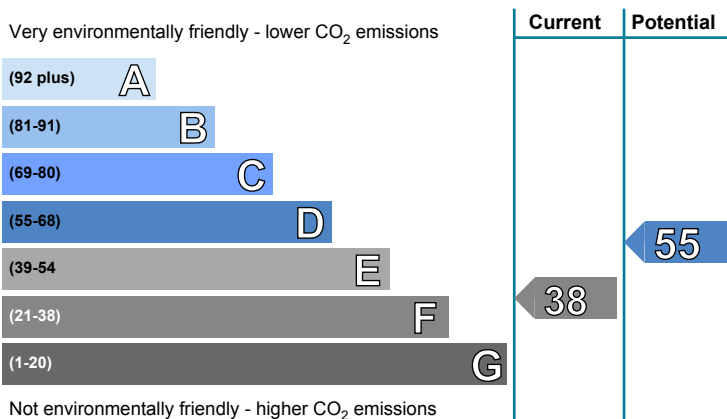
## Environmental Impact (CO<sub>2</sub>) Rating

This graph shows the effect of your home on the environment in terms of carbon dioxide (CO<sub>2</sub>) emissions. The higher the rating, the less impact it has on the environment.
